SH304933 Clearance Gauge for John Deere STS Combines

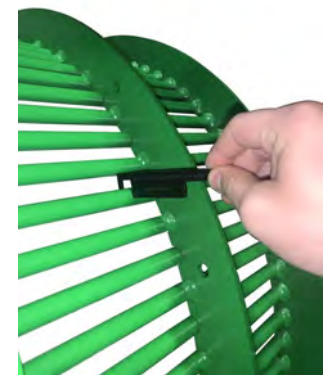
Figure F doesn't need to be replaced.

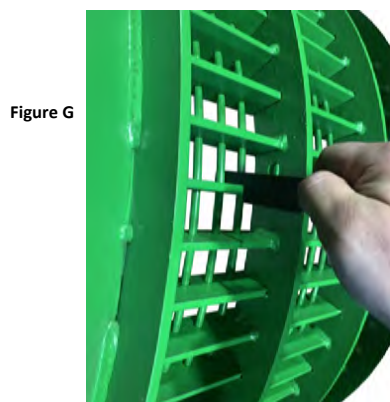
Figure G

When the "grain" side of the gauge can fit over any cross bars on small/large wire concave, as seen if **Figure G**, the concave should be replaced.
